Federal Railroad Administration

RR 17-07 | May 2017

# INDUSTRY SURVEY OF BOLSTERS AND SIDE FRAMES REMOVED FROM SERVICE

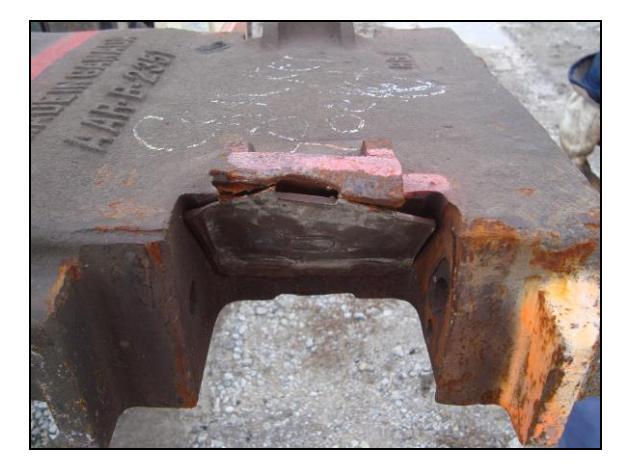
For bolsters, the survey found the most common problem area was the pocket. Worn pockets and cracked pockets accounted for almost 60 percent of the defects severe enough for removal from service. Figure 1 shows a cracked pocket in a bolster.

Figure 1. Cracked pocket in a bolster removed from service

Reducing the top two or three scrap causes would eliminate more than 50 percent of the scrapped components recorded in this research. Eliminating cracked pockets or reducing pocket wear would greatly reduce bolster scrap.

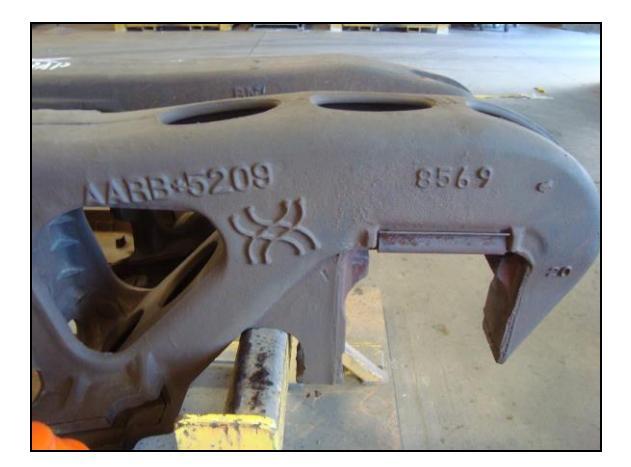
Approximately 70 bolsters and 55 side frames were examined for this survey. In a few cases, multiple defects were evident in one casting. Figure 2 shows the cracked pedestal jaw area of a side frame removed from service.

Figure 2. Cracked pedestal jaw of a side frame removed from service

The side frames had cracked pedestal jaws and bent pedestals that accounted for 50 percent of the defects. The pedestal jaws usually experience the highest loads during service.

Eliminating side frame defects of cracked pedestal jaws and bent pedestals would greatly reduce side frame scrap.

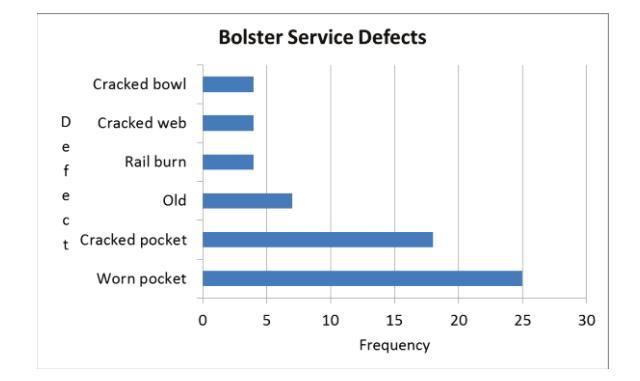
For bolsters being analyzed, TCCI personnel recorded 12 types of defects during the survey. Figure 3 shows the top six occurring defect types for bolsters; they accounted for 83 percent of the defects in bolsters examined for this survey.

#### Figure 3. Top six bolster defects

The majority of the bolster defects were cracked pockets and worn pockets. Old castings, rail burns, cracked webs, and cracked bowls were the other leading defects in bolsters. Figure 4 shows a cracked bowl in a bolster.

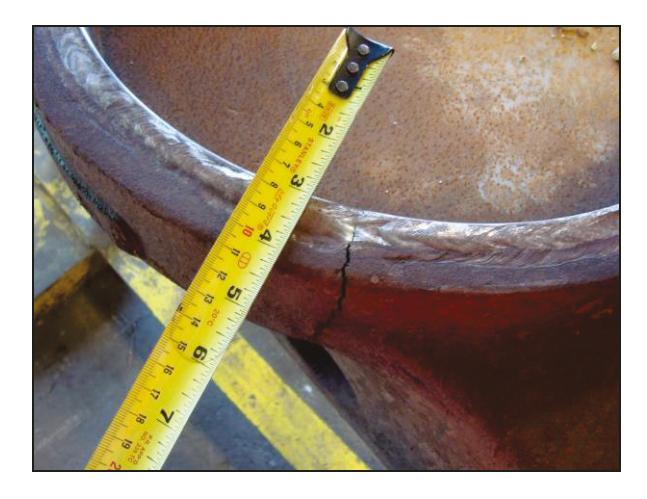
#### Figure 4. Cracked bowl in bolster removed from service

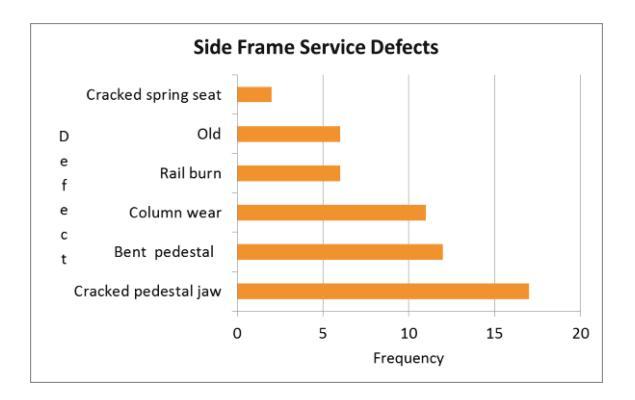
For the side frames, nine types of defects were recorded during the survey. Figure 5 shows the top six side frame defects, which represent 93 percent of the defective side frames examined.

#### Figure 5. Top six side frame defects

Worn columns were also a significant problem, occurring in 19 percent of the side frames. Rail burns, old castings, and cracked spring seats completed the top six defects in side frames.
