U.S. Department  
of Transportation  
**Federal Railroad  
Administration**

RR 21-23 | November 2021

# LINE-OF-SIGHT ANALYSIS USING DRONES AND PHOTOGRAMMETRY

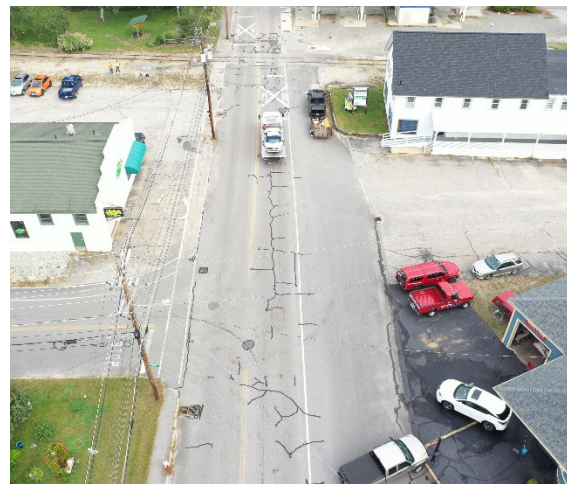
Volpe identified two crossings in Milford, New Hampshire, that had these conditions. A team of Volpe researchers used a drone to capture a set of aerial photographs of these crossings. One of these images, taken at the South Street crossing, is shown in [Figure 1](#). These images were later processed into orthomosaic images,

**Figure 1. South St. Crossing in Milford, NH**
